CAPITAL NEEDS ASSESSMENT

SAMPLE LOCATION

**MAIN STREET
SAMPLE, VT 00000**

Inspection Date: MM/DD/YYYY

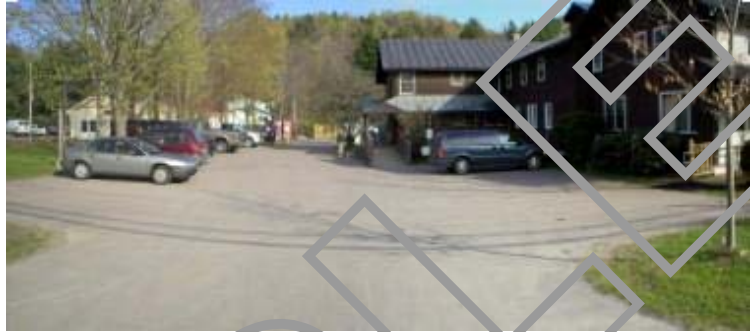
- The area at the curb cut is being eroded due to vehicular traffic cutting the corner too sharply. Budget to extend paving to the affected area.
- Budget for miscellaneous driveway and parking area repairs in 5-year intervals beginning in year 6.

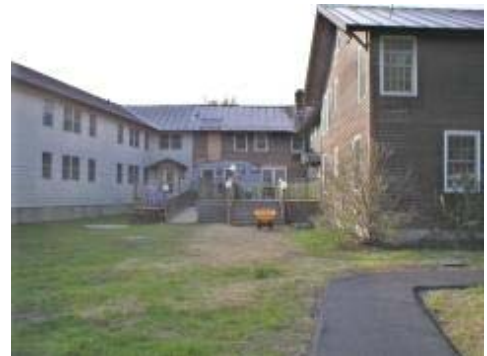
- No extension to the central west elevation deck currently exists. Budget to add in year 2. Estimate 60 feet.

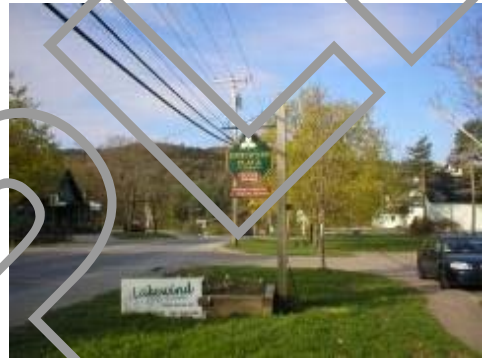
- Trees and shrubs should be pruned to provide several inches of clearance from the sidewalls in order to prevent premature deterioration of the paint and siding.
- Damage to front lawn needs to be restored at completion of construction.
- The sign on a rusty frame in the front yard needs to be restored or replaced.
- The 4-tier castle wall planter in the back yard is missing two sections at the top.

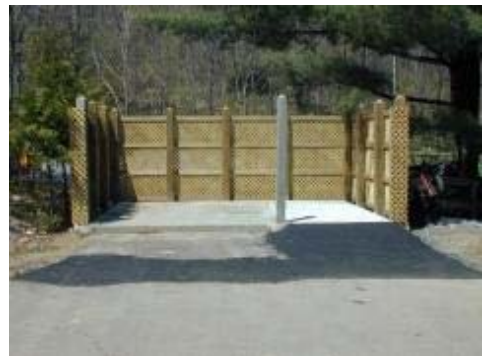
- There are no bollards to protect the back wall at the present time.
- Provide annual application of waterproofing sealer to appropriate surfaces to prolong useful life (operating budget).

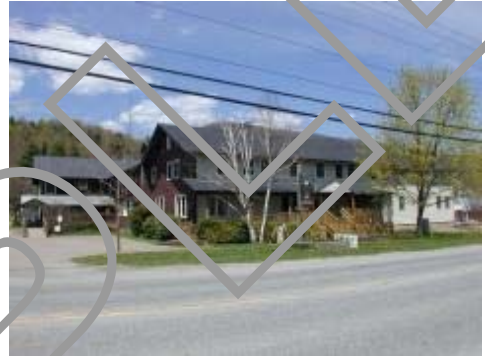
- Re-staining is needed in limited areas, caulking has been completed.
- Budget to refurbish in 6-year intervals beginning in year 6.

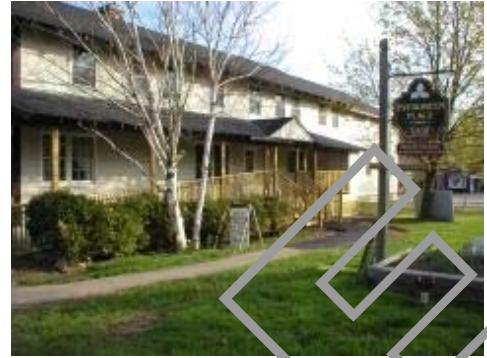
- Annual application of waterproofing sealer is recommended to prolong useful life.
- Pipe handrails on the ramps and steps that need to be sanded and refinished are scheduled to be included with the remodel.

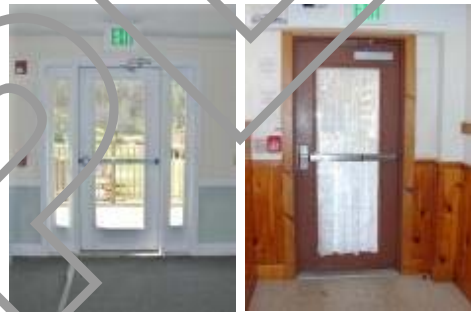
- Budget for replacement of the mechanical area door in year 14.
- Budget for replacement of older doors in year 20.

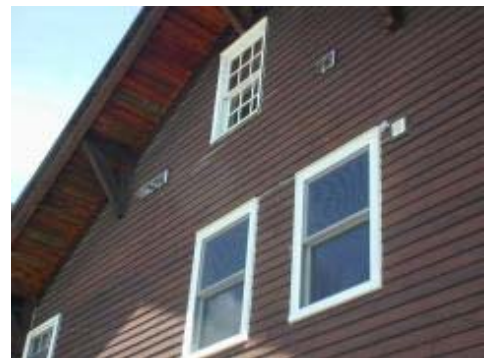
- Check the caulk around all windows and doors and caulk any voids.
- Replace glazing on windows where it is missing or cracked.

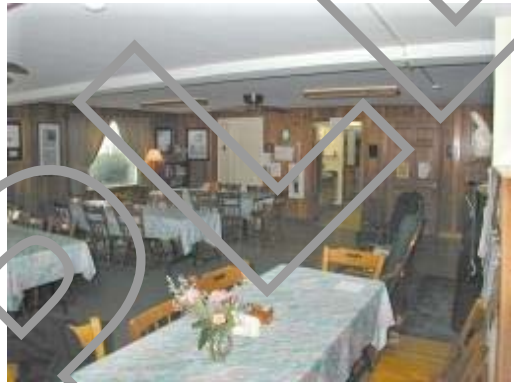
- Budget for carpet replacement in year 8.
- Budget for replacement of 2630 sq ft of VCT and sheet vinyl flooring in year 12.
- Repairs are needed at the south entry (operating budget).
- Budget to refinish hardwood flooring in year 12.

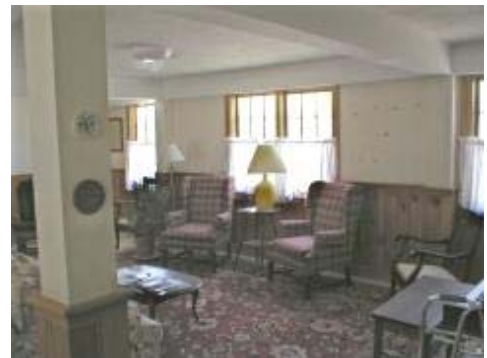
- Budget to refurbish common area walls in 5-year intervals as necessary, beginning in year 5.

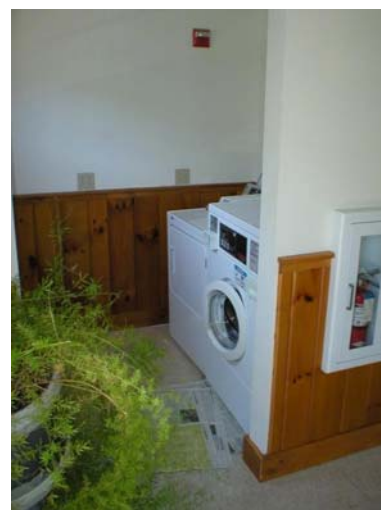
- Budget for laundry appliance replacement in year 8.

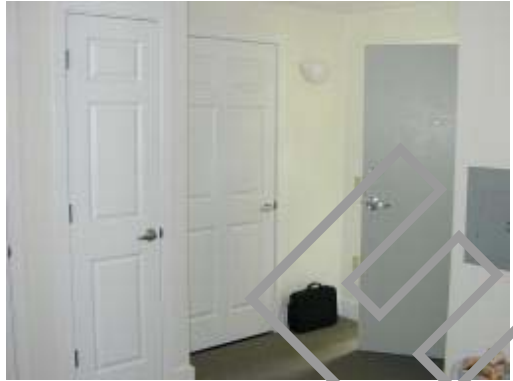
- Budget to replace the existing 28" bathroom door in unit #13 with an accessible width door.

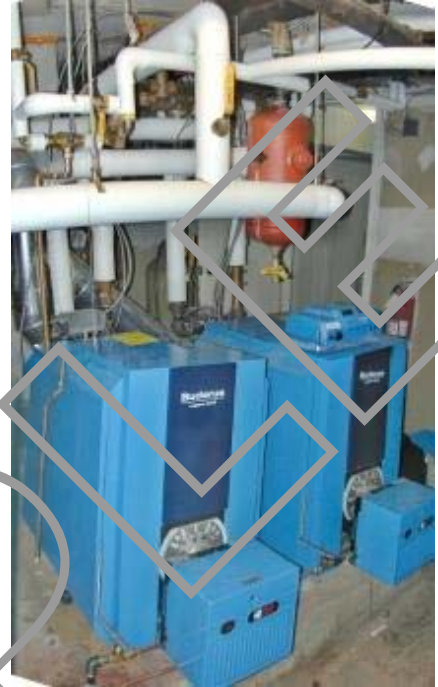
- The boiler room could use a good cleanup.

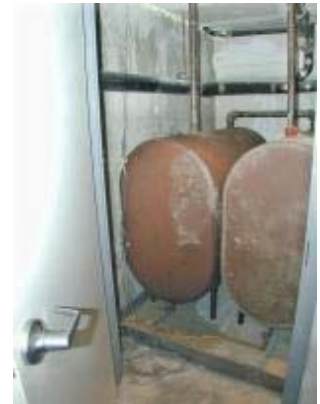
- Some pipe insulation has been disturbed and needs to be restored.
- The unprotected fuel line from the oil tanks to the boiler room is pinched (near the hot water tank) and should be replaced. Budget for year 1.
- Boiler room valves are bronze. Repack gate valves in 10-year increments. Check/repack drain valves in 3-year increments. Replace drain valve stems in 8-year intervals.

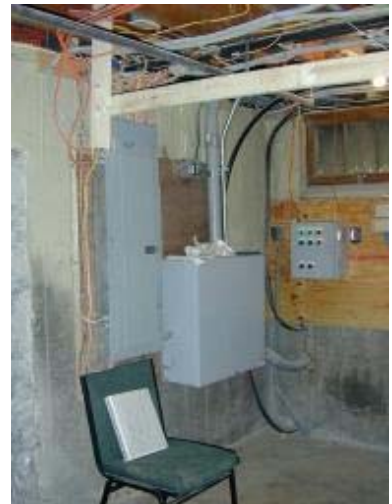
- Budget for replacement of older emergency light units in year 13.
- Open junction boxes in the boiler room need to be covered properly.
