CAPITAL NEEDS ASSESSMENT

SAMPLE LOCATION

**MAIN STREET
SAMPLE, VT 00000**

Inspection Date: MM/DD/YYYY

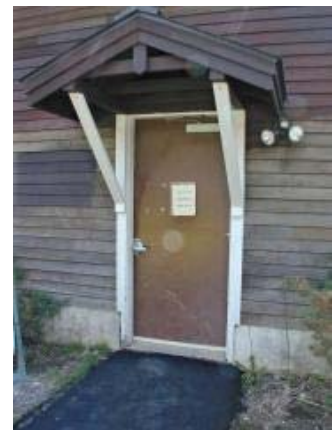
The overall roof structure appears to be in good condition with no noticeable deflection. Roof coverings include asphalt shingles on the north wing and the main building west elevation roofs. New asphalt shingles are installed on the east elevation roof and entry canopy, and the new addition.

- Budget for replacement of older asphalt shingles in year 7.

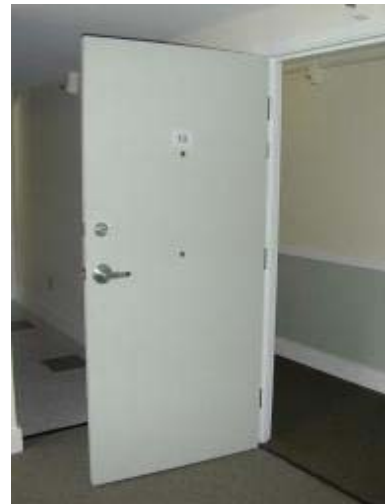
All unit exterior doors open to interior corridors. There are no dwelling units that have direct access to the outdoors. Flush solid core Warnock-Hersey natural finish 90-minute fire rated birch doors are mounted in metal frames, and brushed chrome lever hardware, deadbolt locks, peepsights and spring loaded hinges is typical. Door number signs include characters in Braille. Low secondary peepsights are provided in handicapped units.

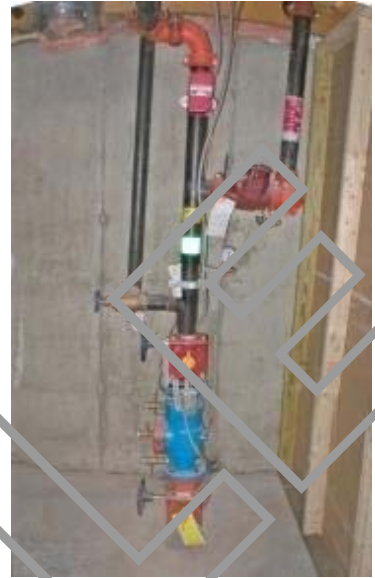
The building is fully sprinkled with dry loops for porch area protection. The sprinkler system is tied to the water supply shared with the shopping center. Sprinkler pipes in the basement areas are exposed. Sprinkler heads include upright, pendant, sidewall and stickup varieties. Pipes in the hallways and living areas are concealed. Fire extinguishers are installed in the hallways and there is an AUTO SPKR Dual fire department hose connection located on the east elevation of the north wing.
